#27 Castle View from November 9th 2005 am

Craig here are new pictures from this morning since it rained a little around 3 or 4am this morning.. Since I have to still get up to move towels to our front door, I took these shortly after..

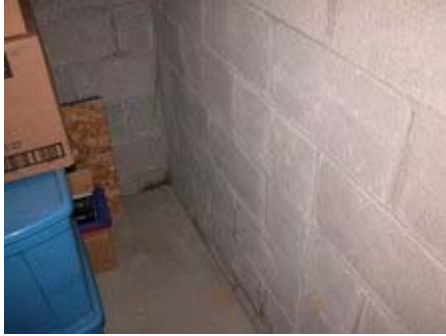
DSCN0149.JPG
33K

Picture 149 and 150 is now around the corner of the far basement wall. It didn't rain heavy and this basically almost looks the same as before the J channel and vapor barrier were corrected...
